Waterproofing Systems

Horizontal barriers against rising damp in masonry

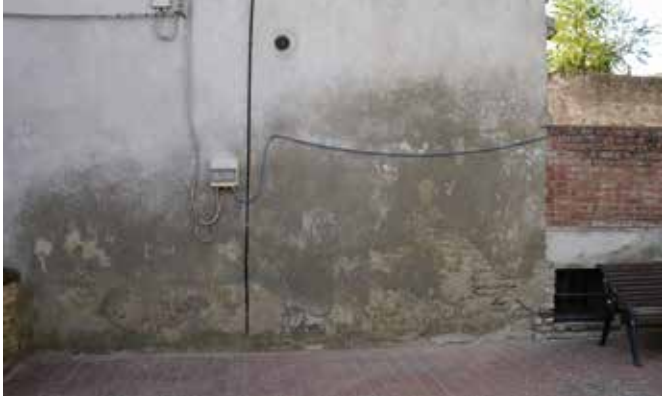
Change of color, reduction of the thermal insulation

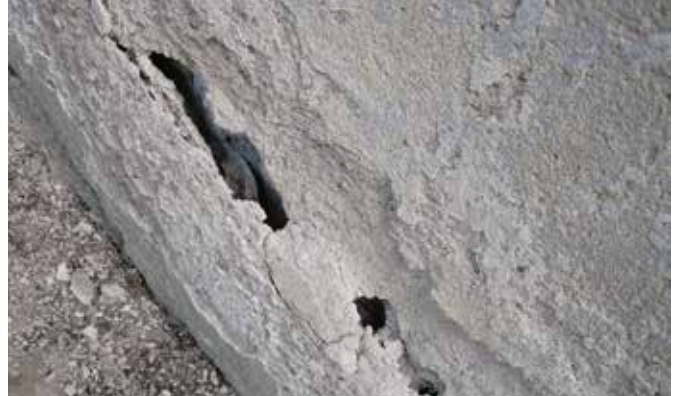
Damaged plaster

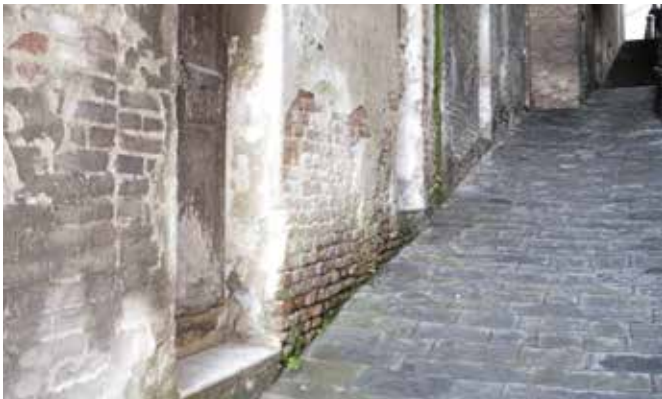
Destruction of render and mortar joints

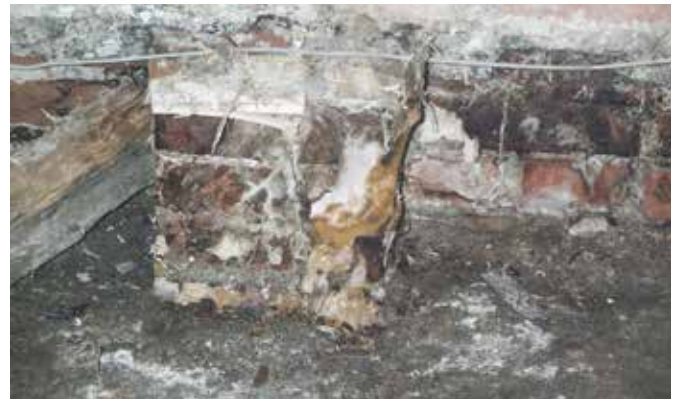
Development of mold and damage to the fabric of the structure

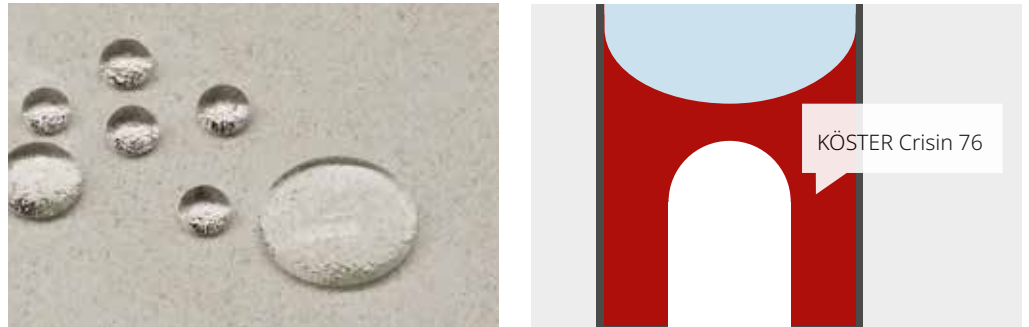
Hydrophobizing: Making the building material water repellent

Narrowing/blocking the capillary, forming an elastic film in the capillary

There are two fundamental ways to stop rising damp: Blocking capillary active pores or hydrophobizing their structure. Hydrophobizing the surface of a pore means to modify the surface tension so that it becomes water repellent (hydrophobic). Thus, the capillary action of that pore is stopped. Blocking a pore means to partially or totally fill the pore in order to stop the transport of water. It is crucial to bring enough material into the pore so that the diameter of the pore is narrowed far enough that no more capillary action can take place.

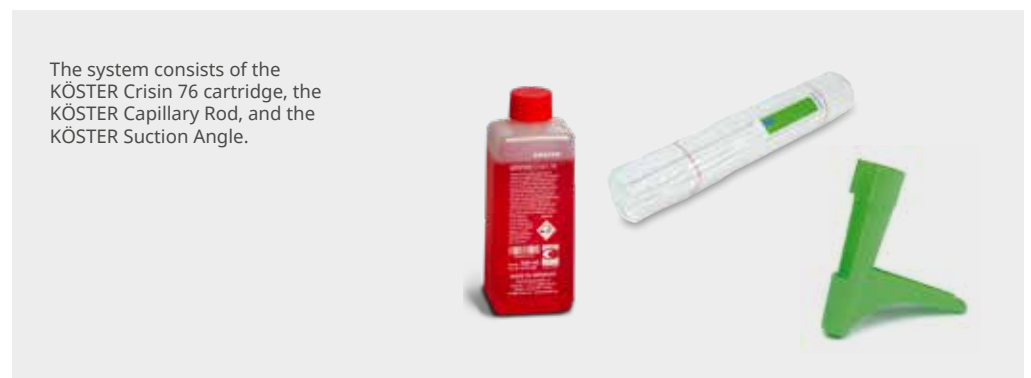
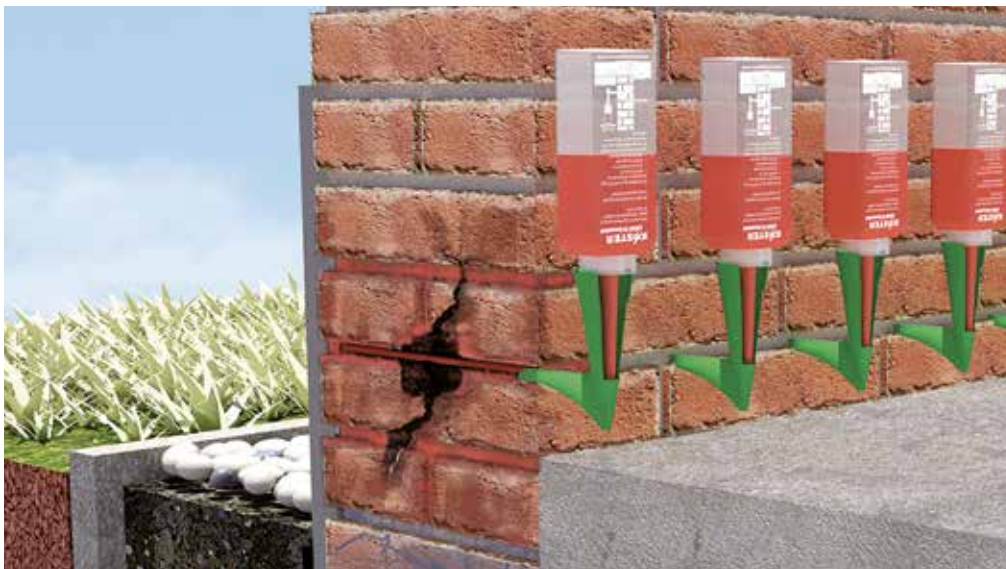
The patented KÖSTER Suction Angle System:

The patented KÖSTER Suction Angle System is the result of decades of experience and development work by the KÖSTER BAUCHEMIE AG. The horizontal barrier is distributed through the capillary transport itself, stopping the rising damp with its own physical cause.

The KÖSTER Capillary Rod acts like a wick, one end is inserted into the wall and the other end into the KÖSTER Suction Angle. From there, it draws the injection liquid into the wall. The KÖSTER Capillary Rod is available in lengths of 45 or 90 cm.

Schematic representation. Actual circumstances may differ in reality.

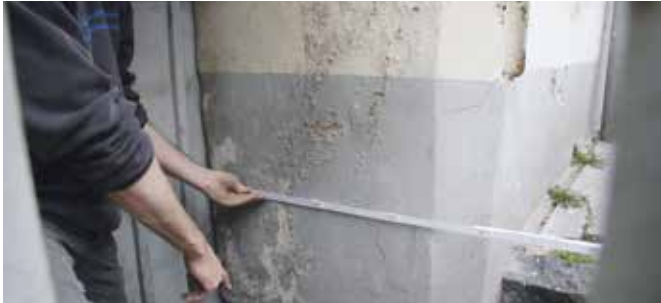
1 The salt and moisture contents are high in the masonry, the existing plaster is damaged.

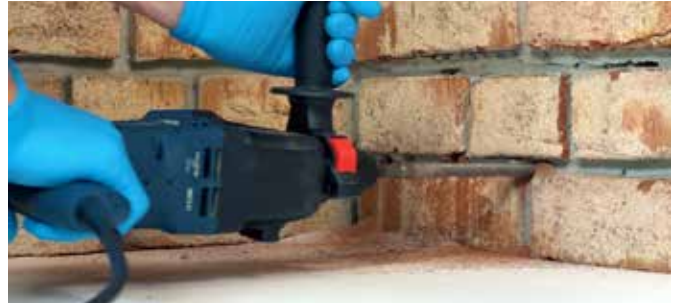
2 Boreholes are drilled into the inner wall with a distance of 10 cm from one another and depth of 40 cm (Wall thickness: 45 cm and 30 cm above grade).

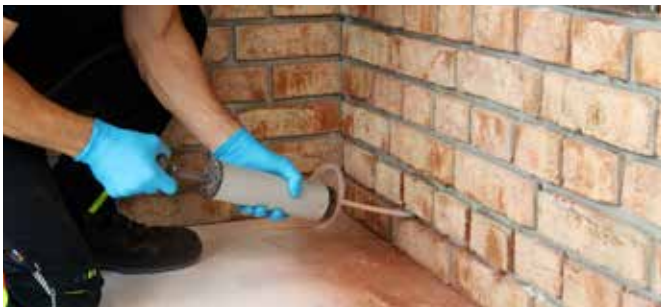
3 The boreholes are cleaned from dust by blowing the dust out of the borehole with pressurised air.

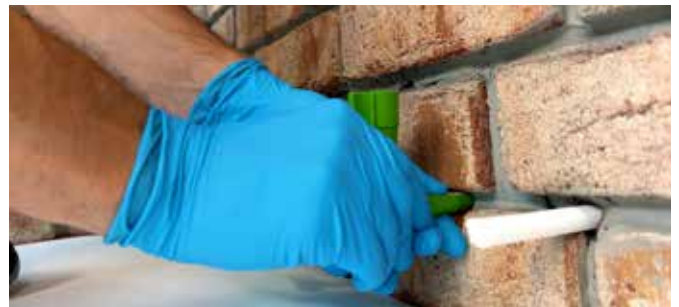
4 KÖSTER Capillary Rods are installed so that they protrude 7 cm from the borehole.

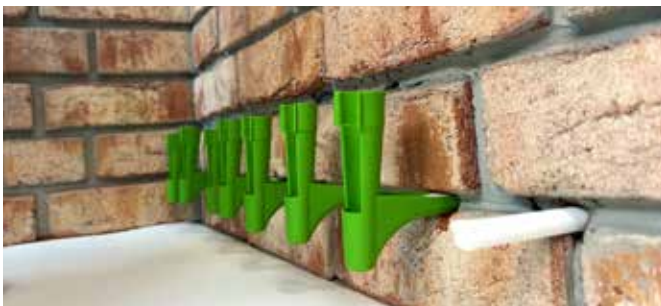
5 The KÖSTER Suction Angles are installed so that the KÖSTER Capillary Rods reach into the supply chamber of the KÖSTER Suction Angles.

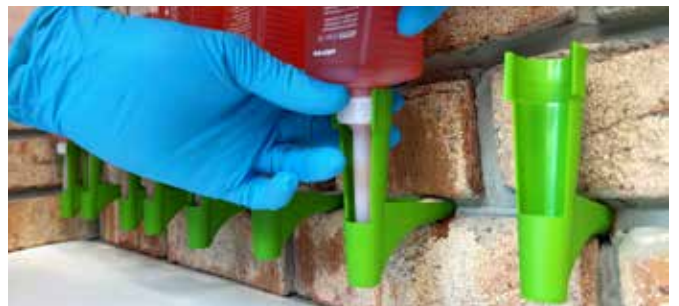
6 The KÖSTER Crisin 76 cartridges are then installed into the KÖSTER Suction Angle.

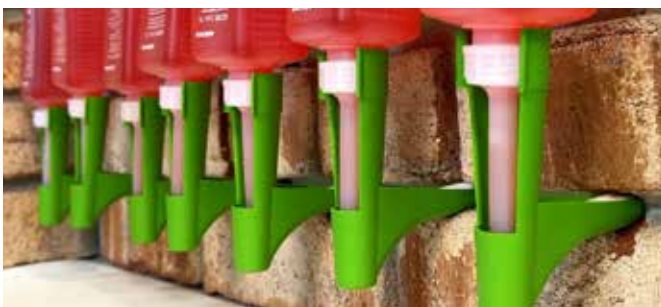
7 The nozzles of the cartridges sit directly on top of the capillary rod and allow the material to be soaked up.

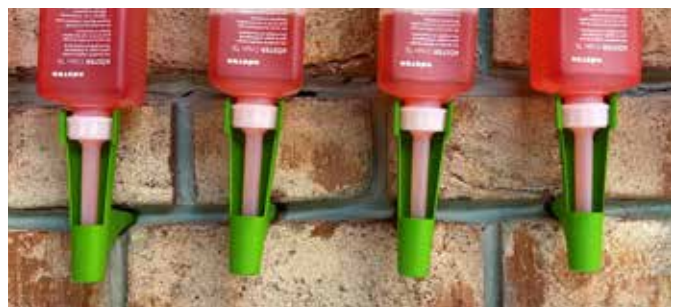
8 The pressureless injection of KÖSTER Crisin 76 into the masonry starts immediately after the installation of the cartridges.

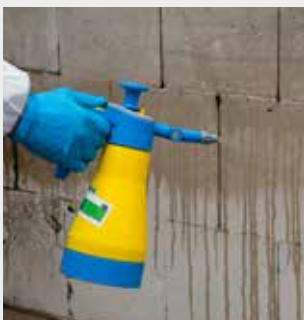
Remove old plaster. Fill breakouts and holes with KÖSTER Repair Mortar. Spray KÖSTER Polysil TG 500 onto the surface to block salts and strengthen the substrate.

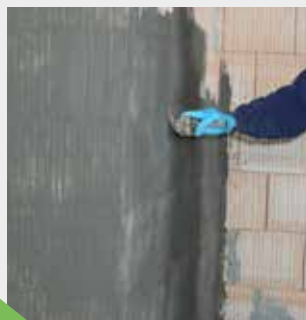
If negative side waterproofing is necessary, KÖSTER NB 1 Grey is applied in two layers.

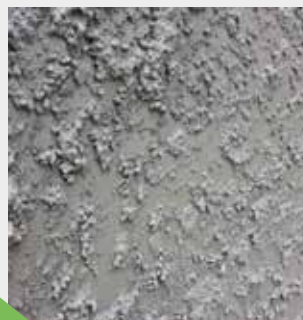
In the next step KÖSTER Restoration Plaster Key is applied to ensure the optimal adhesion of KÖSTER Restoration Plasters.

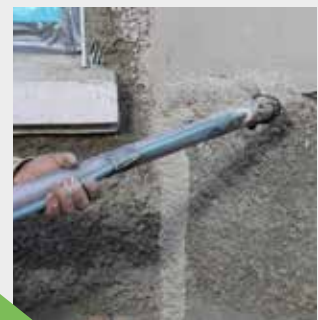
The KÖSTER Restoration Plaster is applied with a trowel or an appropriate mortar pump on the cured layer of KÖSTER Restoration Plaster Key. In the last step the surface is floated smooth.
